Preliminary Habitat Assessment of Southwest Hahamongna

Arroyo Seco Stream Team
August 23, 2012

August 23, 2012

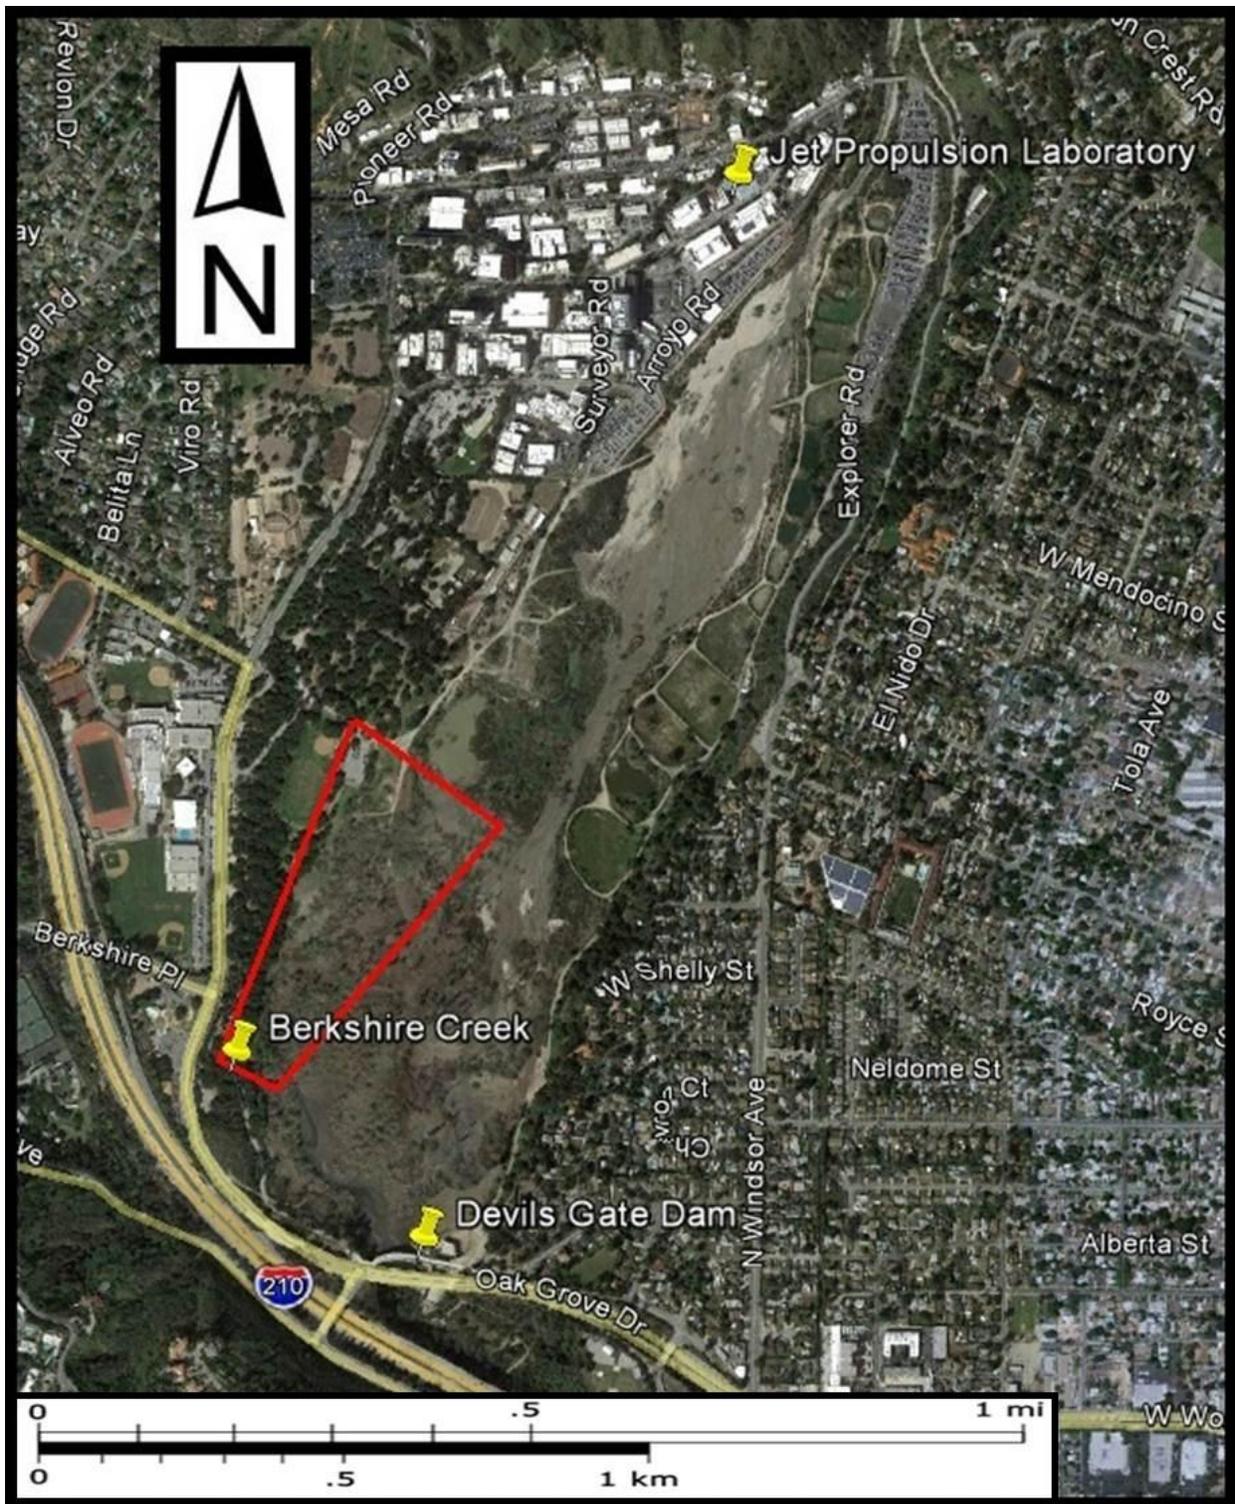
Figure 1. Aerial image of Hahamonga Watershed Park with the Habitat Assessment boundary outlined in red, referenced through GoogleEarth

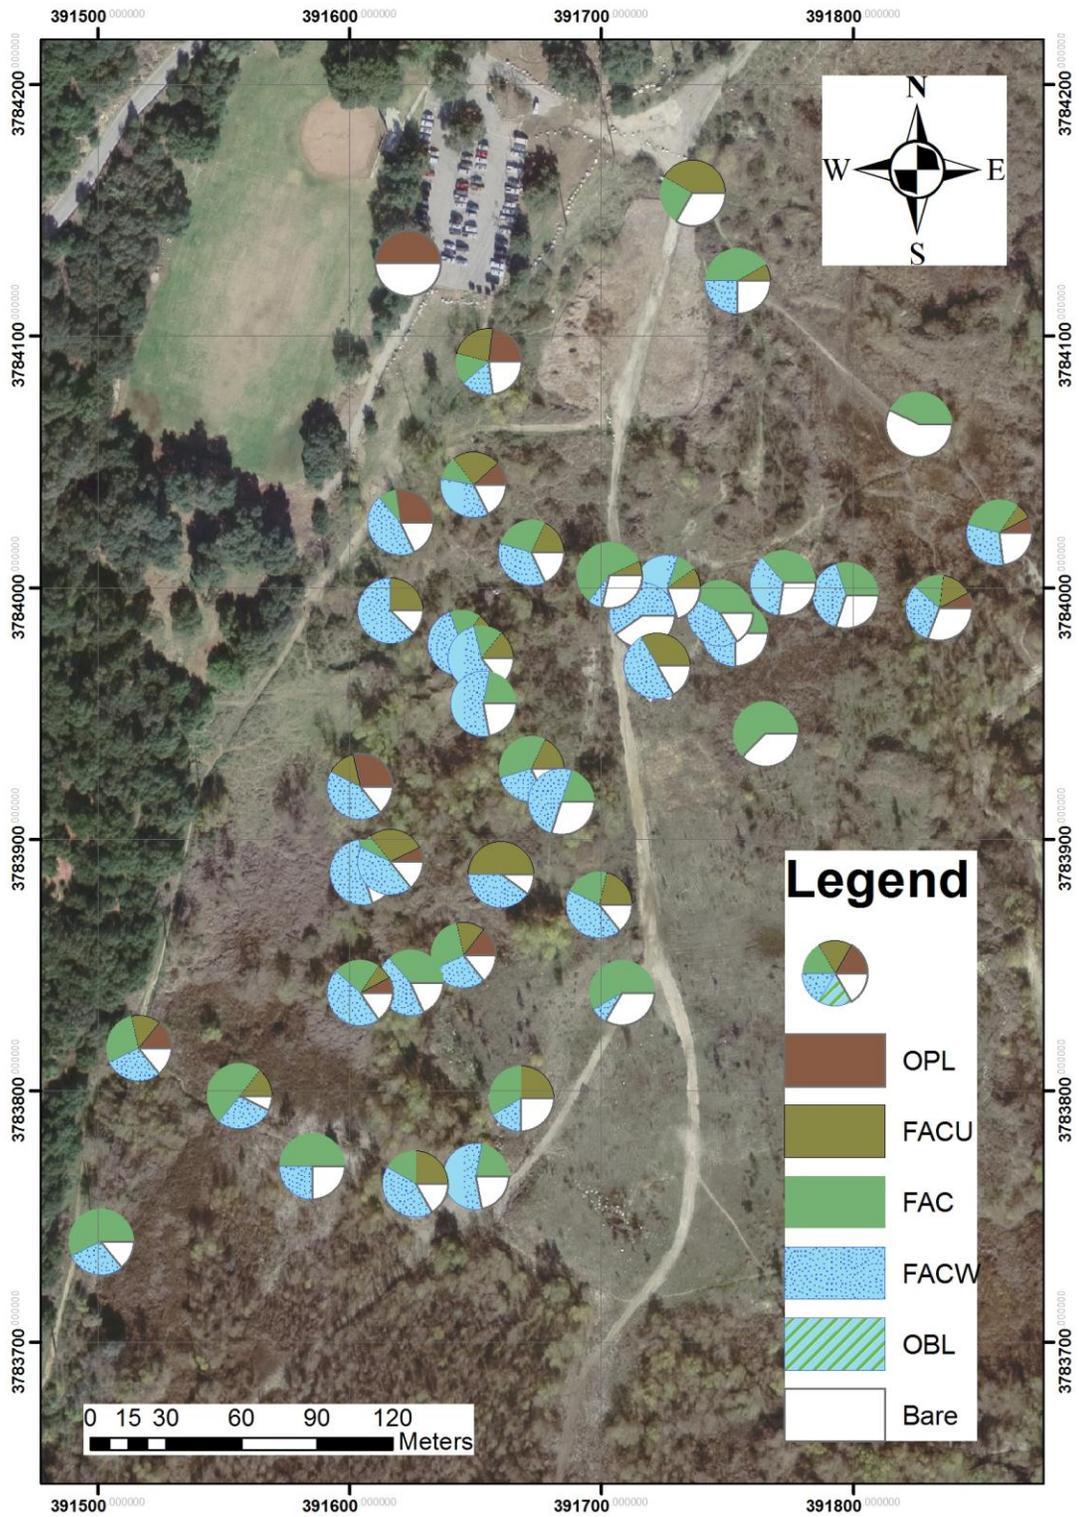
Figure 2. Wetland indicator status survey point inventory

Identified plant species were cross-referenced for their wetland indicator status. The USACE classifies plants that are found with a likelihood of 0.99, 0.66, 0.5, 0.33, .01, as OBL, FACW, FAC, FACU, and UPL respectively. Species with common status were grouped together for calculation of indicator ratios and USACE dominance test and prevalence index test. The prevalence index procedure can be found in the Wetland Determination Data Form in the Arid West Region supplement to the USACE Wetland Delineation Manual. The requirement for the dominance test is such that over 50% of the dominant plant species found must be of indicator status FAC, FACW, or OBL. Data were entered into the ESRI ArcView GIS program for visualization and referencing.

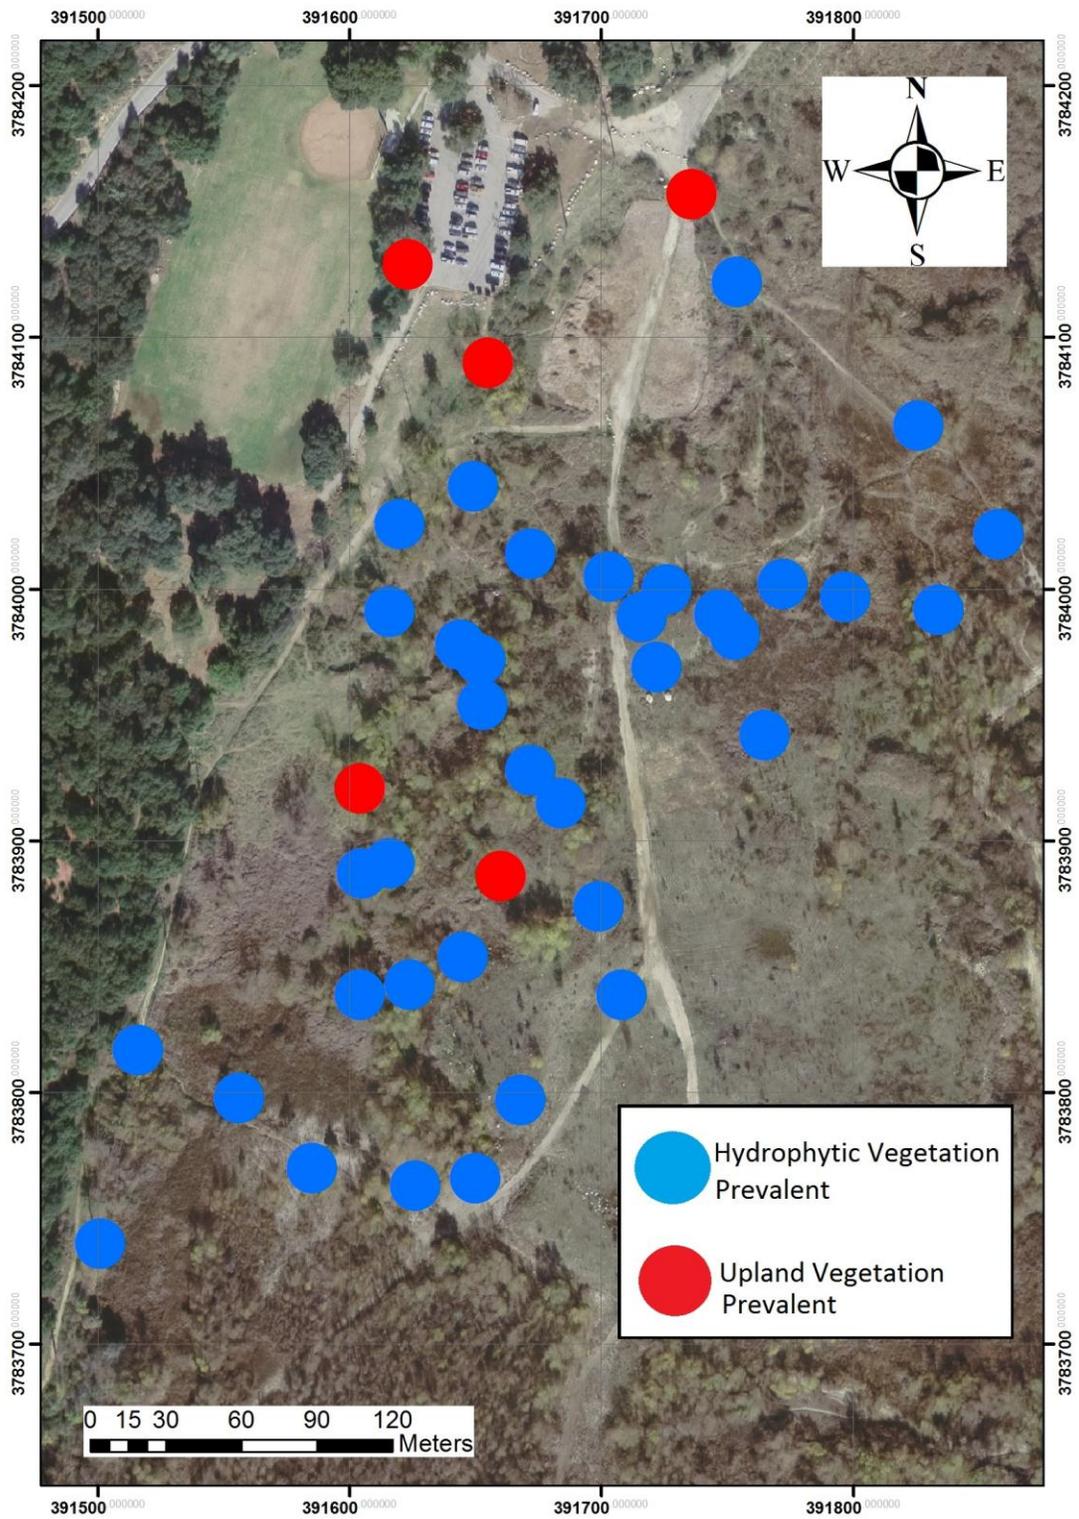
Figure 3 Hydrophytic vegetation prevalence

The study area is characterized by dominant wetland indicator vegetation comprising more than 50% of cover surveyed at most locations throughout southwestern Hahamongna. This classifies most of the surveyed area as wetland by U.S. Army Corps of Engineers standards. Species were largely FAC and FACW in dominant black willow thickets with mosaic mulefat thickets in wide open flow areas and smartweed-cocklebur patches in deep meanders and clay soils. Groupings of OBL species were observed in low woodland openings and meanders. Additional FACW perennial pepperweed patch semi-natural stands were found on slopes and in elevated portions of the wash with UPL exotic associations. Upland coast live oak woodland and upland mustard series are found at the western and southwestern periphery of the study area.

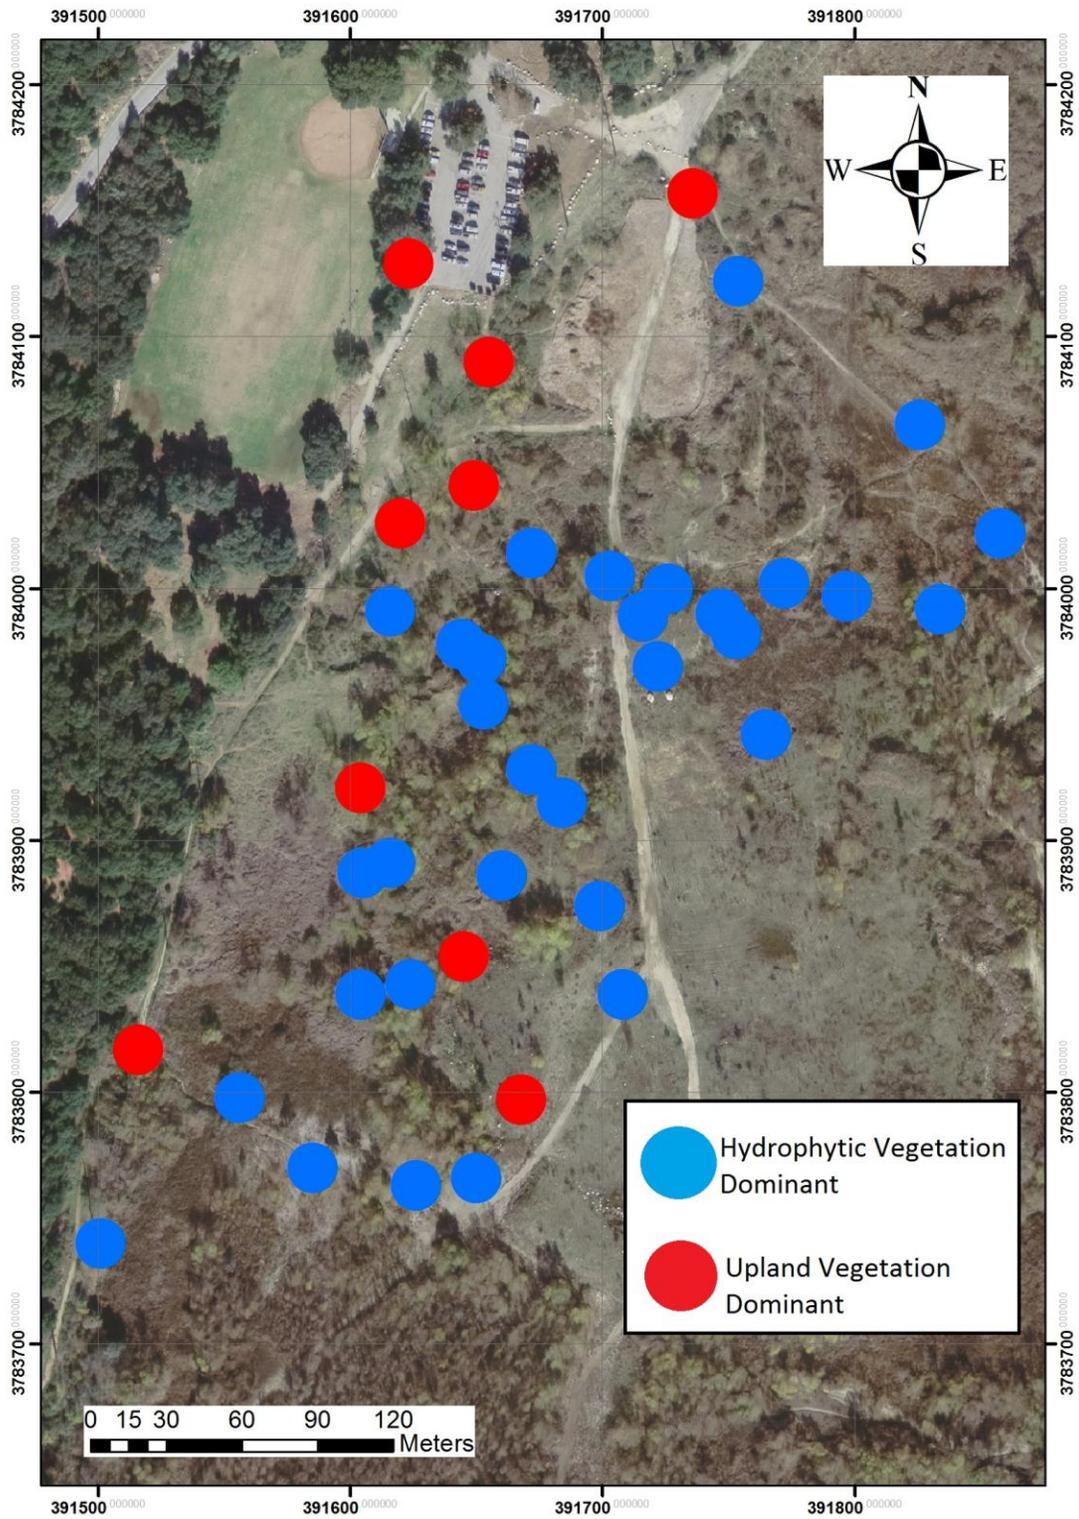
Figure 4. Hydrophytic vegetation dominance

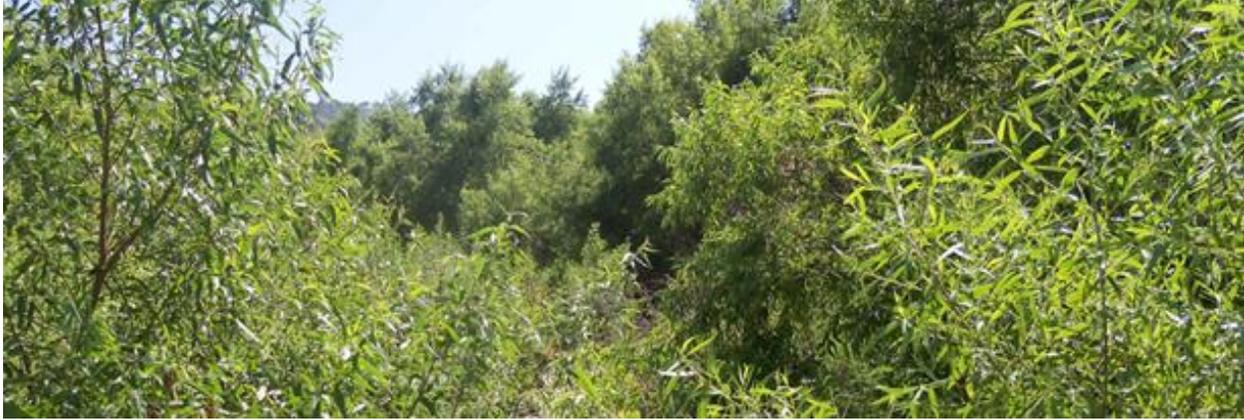
Figure 5. Black willow thicket observed in the SW Hahamongna Basin

Black willow thickets made up the most dominant cover throughout the study area with some stands of tall trees (>30'). Growth was noted both in wide open flow areas with fine course sand soil as well as adjacent and creating canopies over deep meanders, usually opening before clay and compacted soils. Some wide space bare of vegetation is prevalent, especially where deposition seems to indicate strong periodic flows. Exotic species were generally absent or insignificant, with exotic presence observed most significant where slopes and terraces fell under the canopy, particularly adjacent *Lepidium latifolium* semi-natural stands. Black willow species have a tendency to be dominant in more disturbed willow woodland below 1500' in seasonally flooded freshwater conditions with other willows including red willow (*S. laevigata*) and arroyo willow (*S. lasiolepis*) as well as cottonwoods.³⁵ During the study other willow species were largely found in the wide northern sections adjacent and into mulefat scrub. Sometimes important *Populus fremontii* were found establishing adjacent stands with few *P. balsamifera* L ssp *trichocarpa* mature individuals observed. Ranked G4 S3 rare statewide, this association is considered globally threatened by altered and encroached riparian habitat³⁶ with restoration efforts focusing on mimicking natural flood conditions.³⁷

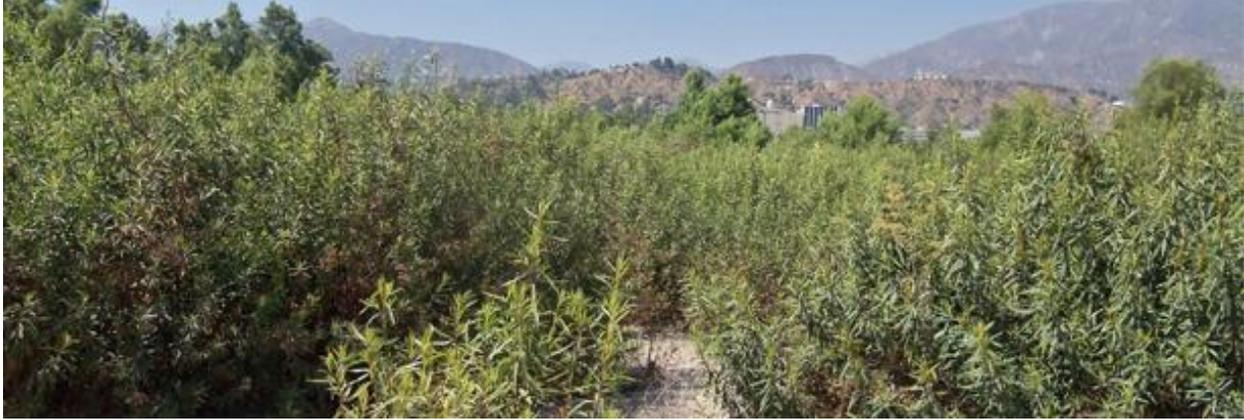
Figure 6. Mulefat thicket observed in the SW Hahamongna Basin

A mosaic of mulefat thickets was observed with black willow thickets, mulefat predominant in wide open flow areas with fine to very fine sandy soils. Emergent *Populus fremontii* were found in stands, as well as *Salix laevigata* and *S. lasiolepis*. Very minimal exotic species presence was with robust near monocultures in large patches observed at time of study, sometimes with wide space bare of vegetation between growth. This alliance is ranked G5 S4 and found below 4000' in highly disturbed areas with seasonal freshwater flooding. The cover is further known to give way to emergent species associations.³⁸

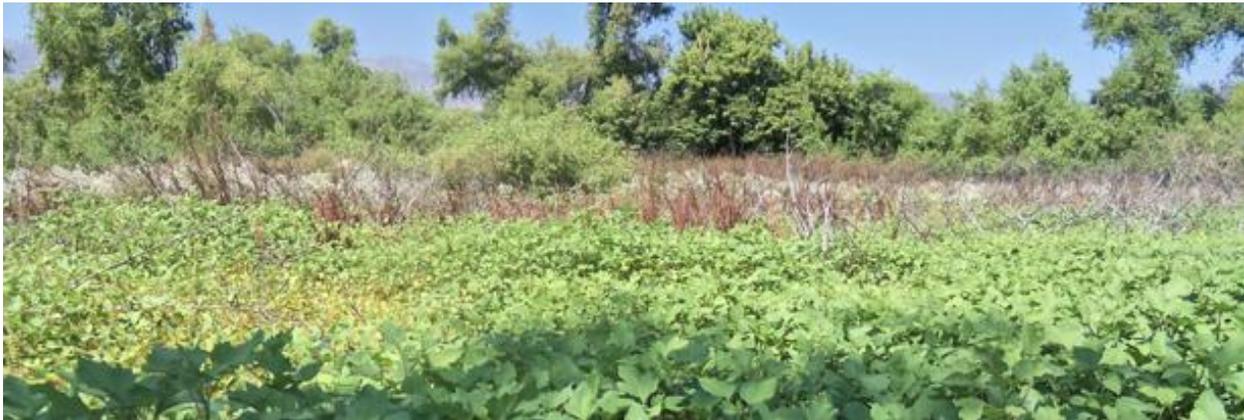
Figure 7. Smartweed-cocklebur patch observed in the SW Hahamongna Basin

X. strumarium (common cocklebur) often created monocultures in low spots and wide meanders with clay soils, growing with more diversity in narrow meanders. *P. lapathifolia* (smartweed) was not observed as important during the study. This cover is associated with weedy native and exotic species in wetlands and emergent wetlands up to 4500' with *P. lapathifolia* tending to prefer slightly more moist conditions. Often very distinct patches were defined by surrounding native cover and exotic monocultures just up slope. Ranked G4 S4.³⁹

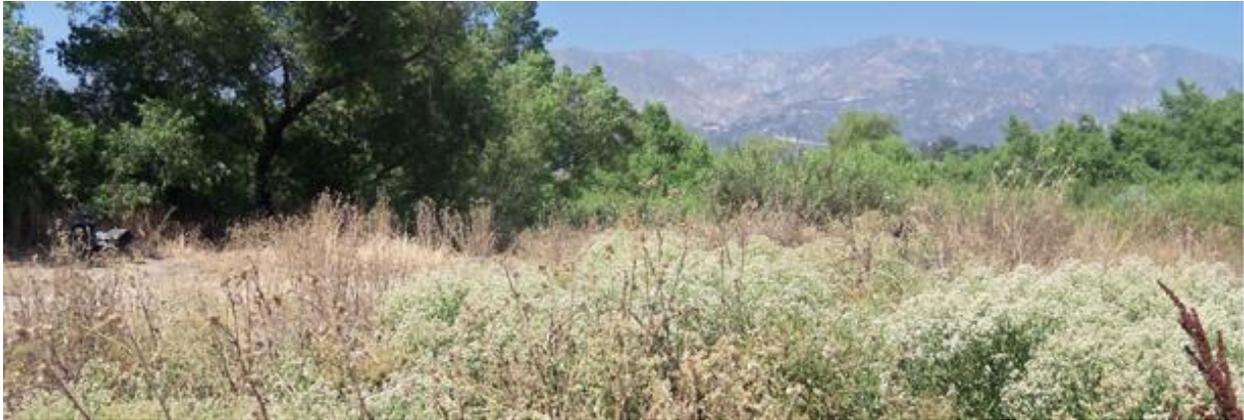
Figure 8. Perennial pepperweed patch observed in the SW Hahamongna basin

Exotic invasive perennial pepperweed was found dominant in monoculture stands on terraces and patches on slopes adjacent both *Salix gooddingii* alliance and just above *Persicaria lapathifolia*-*Xanthium strumarium* provisional alliance. Characterized by exotic invasive species found in moist and semi-moist environments up to 5700' in seasonally flooded fresh and saltwater conditions. *Ailanthus altissima*, *Carduus pycnocephalus*, *Eucalyptus globulus*, and *Rubus discolor* were found adjacent. *Lepidium latifolium* is adapted to spread by rhizomes often broken by flooding, and is known to sprout from fragments smaller than 1".⁴⁰ These stands have no heritage program rank.⁴¹

Lepidium latifolium and *Brassica nigra* semi-natural stands with other exotic invasive associations are dominant on disturbed and compacted terraces and uplands. These conditions unfavorable for native species are important foci for restoration. Regularly disturbed unmitigated spaces, such as the overflow parking, further promote these conditions. Long-term treatment including clearly designated heavy traffic access, establishing appropriate cover for traffic spaces, and appropriate restoration of vegetated spaces limits the prevalence and spread of invasive species. Exotic invasive species removal without improvement will likely result in re-establishment of invasive vegetation. The exotic invasive *Lepidium latifolium* in particular requires careful management as natural spread occurs by rhizomes, known to sprout from fragments smaller than 1".⁵² Uncontrolled disturbance would likely create infestation problems throughout the area and downstream.

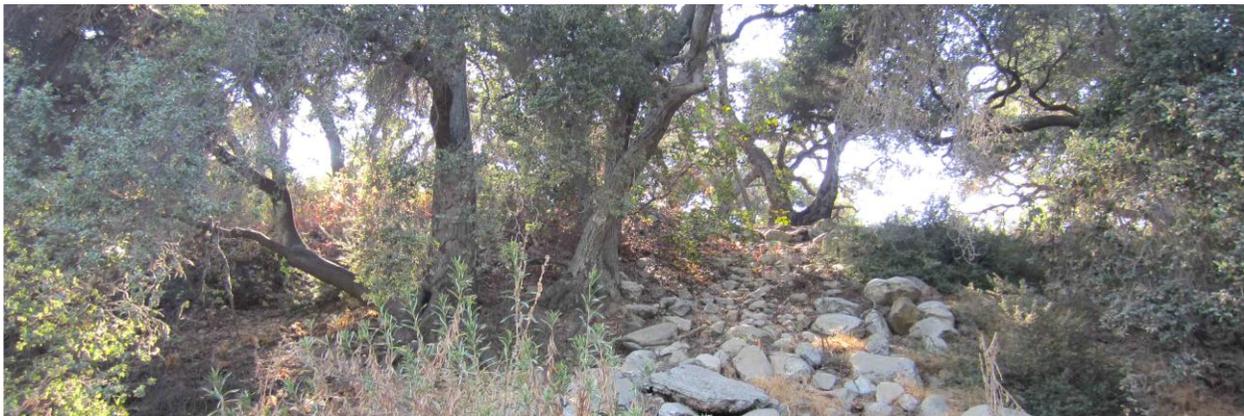
Figure 9. Coast live oak woodland observed at SW periphery of Hahamongna Basin

Coast live oak woodland occurs in upland slopes at the west and southwestern periphery of the study area. Found below 3600' in deep organic soils on alluvial terraces, canyon bottoms, flats, often growing on steep slopes, and sometimes along streams with closed tree canopies. Not listed on the National Registry of Wetland Plants. Ranked G5 S4.⁴²

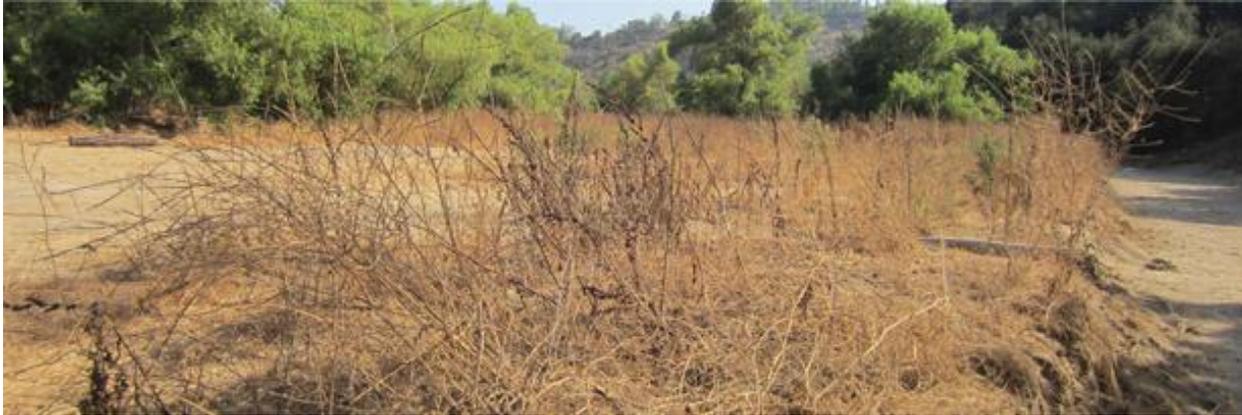
Figure 10. Dried mustard patch observed at SW periphery of Hahamongna Basin

Exotic invasive upland black mustards were observed at the western and southwestern periphery in disturbed and compacted soils in and adjacent to heavily used park spaces and overflow parking. These semi-natural stands are unranked UPL exotic and invasive species associated with exotic invasive species.⁴³

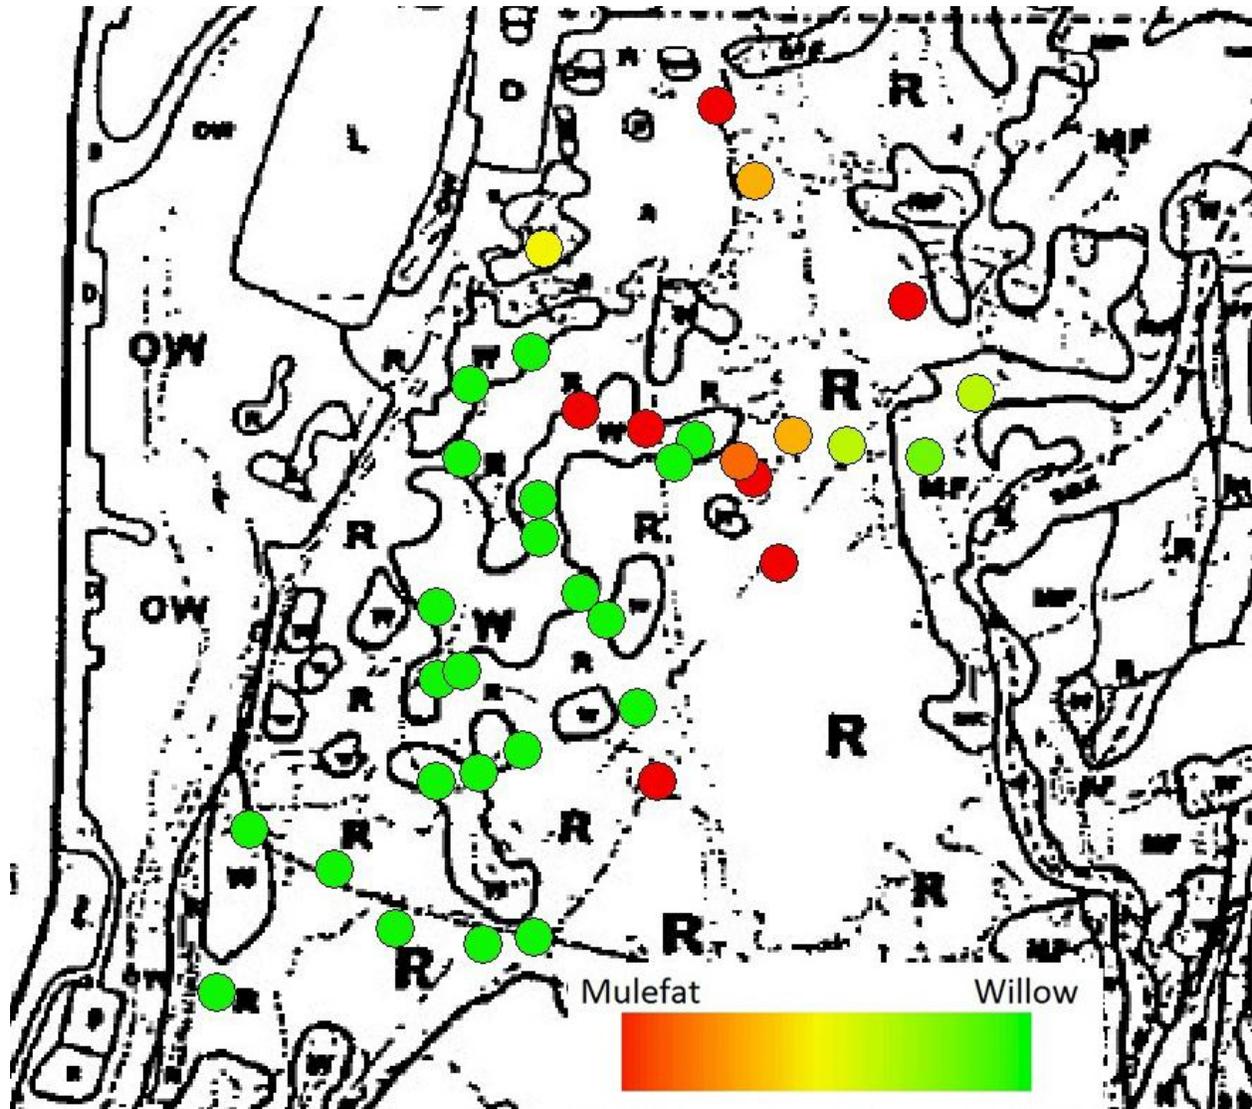
2012 assessment cover overlay over 1998-1999 Parsons survey map

- R= ruderal (described as largely bare and non-native cover dominated by forbs)
- MF= mulefat
- OW= coast live oak woodland
- W= southern willow scrub

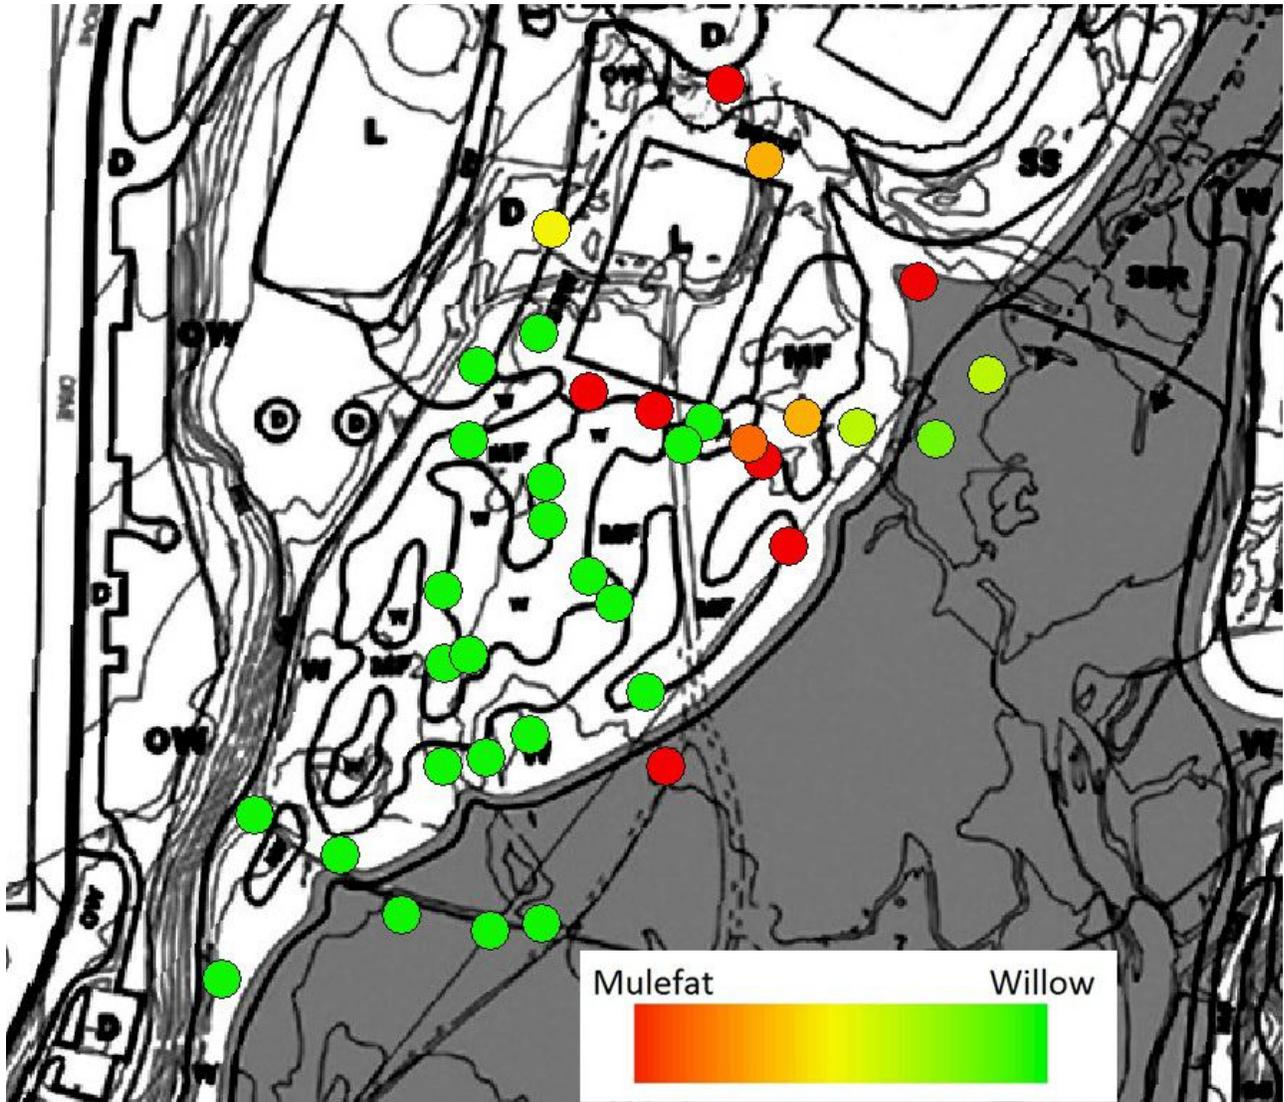
2012 assessment cover overlay over 2003 Hahamongna Watershed Park Master Plan Proposed Terrestrial Natural Plant Communities

MF= mulefat
 OW= coast live oak woodland
 W= southern willow scrub

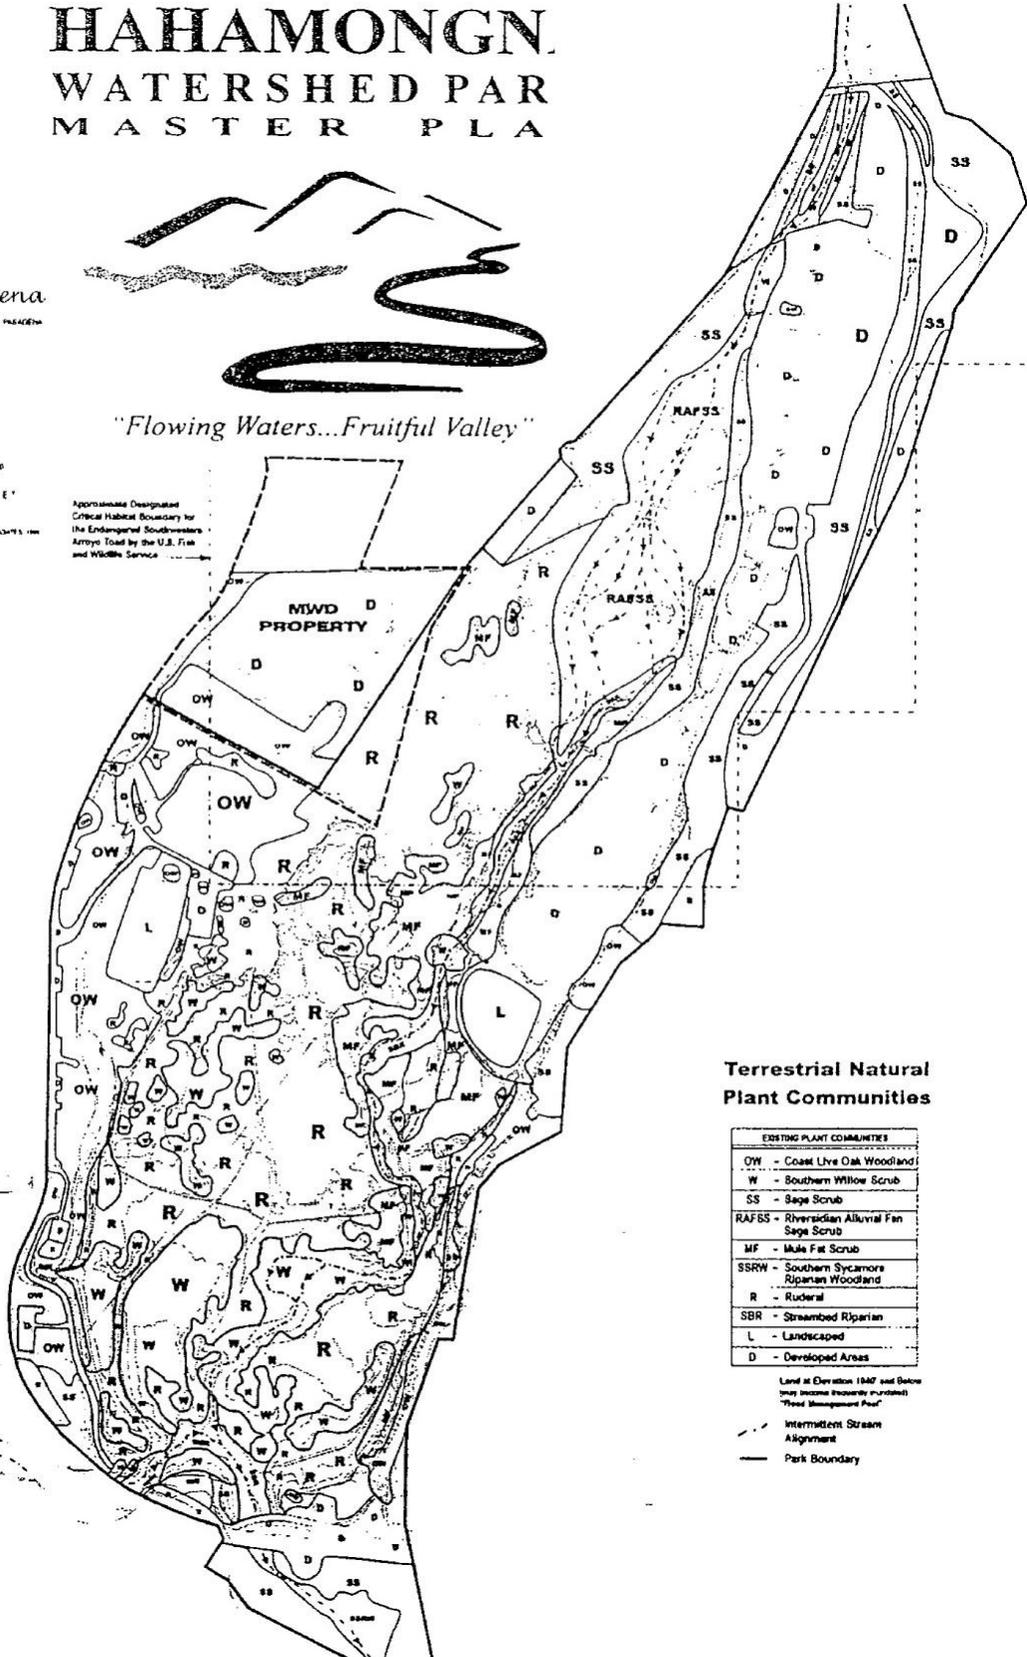
1998-1999 existing conditions map of terrestrial plant communities from 2001 Parson's Study
